Manhole Inspection Summary

Manhole # S19KK1013MH

Insp Date: **7/16/08 3:57 PM**

Location Address: **2011 COLD SPRING LN**

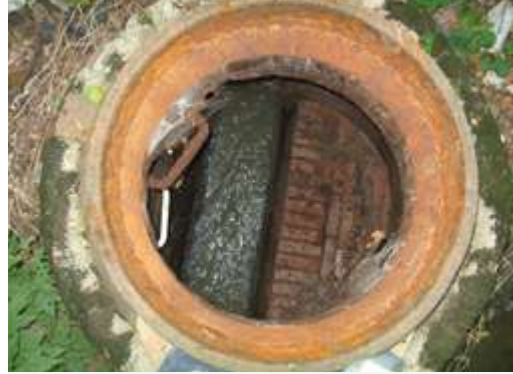
Top View

Frame leaks. Corroded steps. Evidence of surcharge - Bench debris.

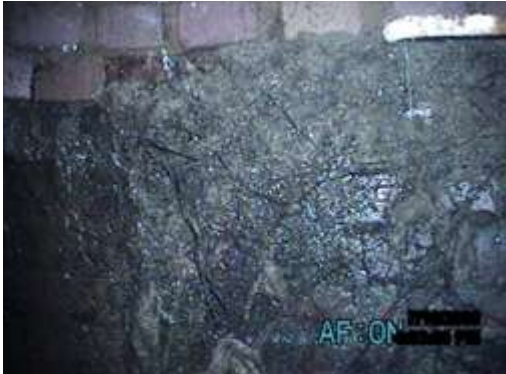
Defect

root growth as well as infiltration

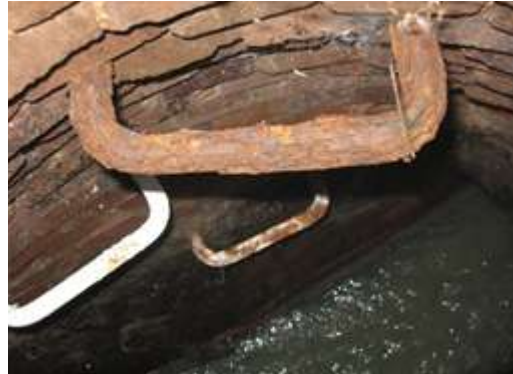
Defect

Corbel infiltration. Barrel root intrusion and infiltration.

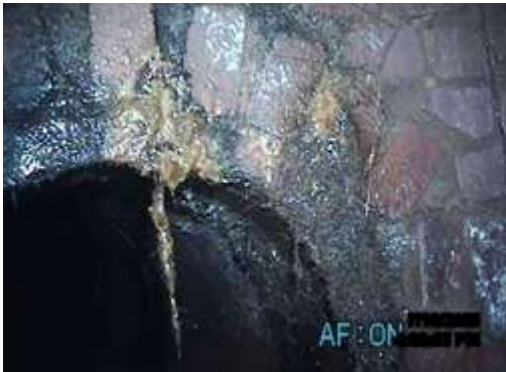
Defect

Barrel root intrusion and infiltration.

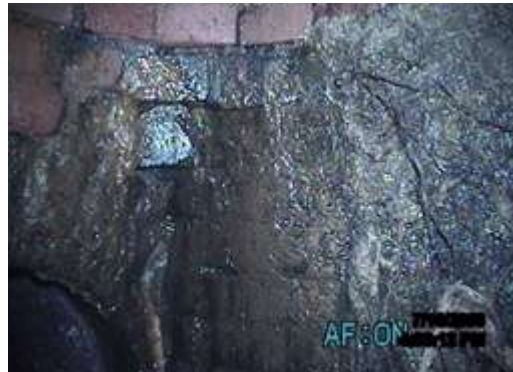
Defect

Corbel root intrusion and infiltration.

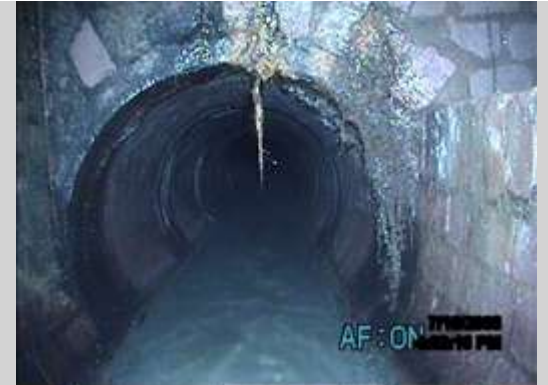
21 in. Circular Gravity Sewer Pipe Out @ 12 O'Clock

Infiltration: **None** Pipe Seal Cond: **Roots**
